Tracking Adaptation and Measuring Development (TAMD) in Kenya

Irene Karani and Nyachomba Kariuki

Q3 Report - Feasibility Testing Phase

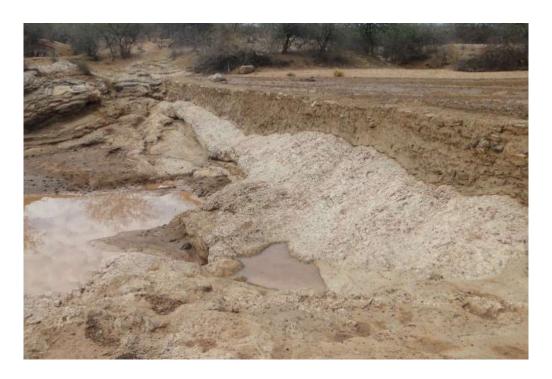
Photo 1: Lbaaoirbor sand dam

One of the sand dam's that requires rehabilitation is Lbaaoibor sand dam which has a weir approximately 60metres long. The dam is estimated to have a capacity to hold 10,000 m³ of water and is accessible as it is near the road. The dam is used during the drought season and needs to be rehabilitated as one end of the sand dam is broken and needs to be extended. The rehabilitation will also include increasing the height of the dam by 0.5metres. The sand dam also a natural dam downstream. No community members were interviewed as there were none near the site

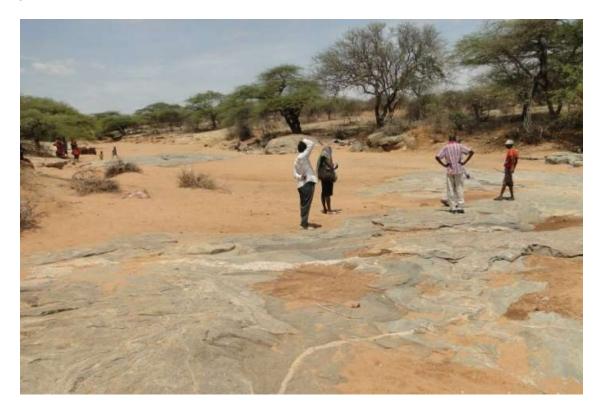
Photo 3: Nooloroi - new sand dam site

Nooloroi is one the proposed sites for the construction of a new sand dam, it is situated near a road hence is accessible and is estimated to have a capacity of 15,000m³ of water. The site was chosen as the area surrounding it has a solid, contiguous rock bed. There is another sand dam nearby (along the same river) that was constructed by the Catholic diocese several years ago.

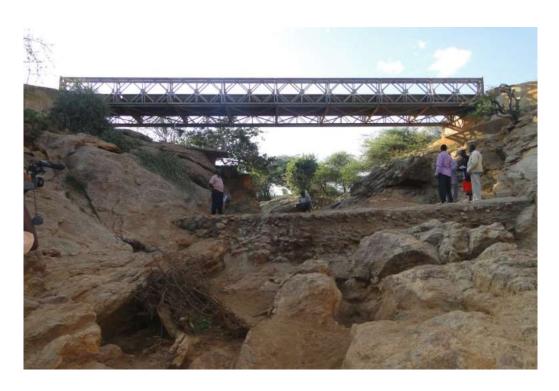
Photo 4: Mlima Chui site-sand dam rehabilitation

One of the sand dam's that require rehabilitation is the Mlima Chui sand dam which is approximately 30 metres long, and is estimated to have a water holding capacity of 15,000 m³. The dam is situated near a road and is therefore accessible. The rehabilitation was planned as the dam has a crevice at its base that has allowed water to leak, thereby reducing its water storage capacity. The monitoring team visited the site and observed the crevice.

In Mlima Chui, the women indicated that the existing sand dam negatively impacted water availability because the stream flowed reliably in the past. Water in the sand dam lasts for only one month after the rains, possibly due to seepage through a crevice at the sand dam's base. They preferred that a new sand dam be constructed further downstream as opposed to rehabilitation of the existing one. The water engineer indicated that it can be repaired, and suggested that the WAPC considers negotiating with the contractor to undertake this as part of the rehabilitation work.

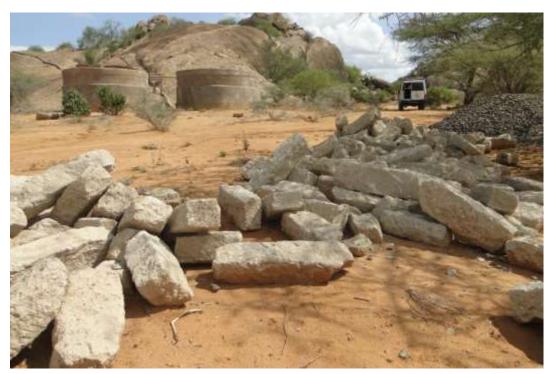
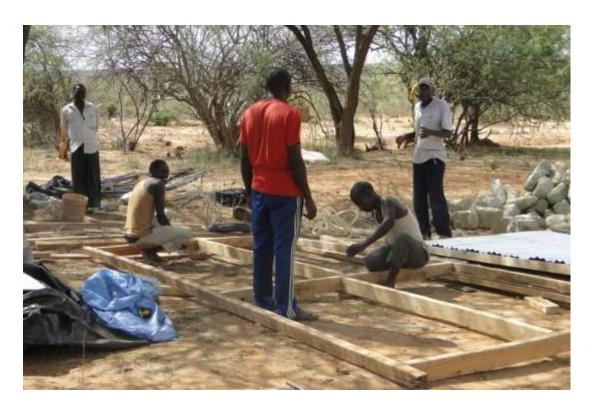
The monitoring team found workers onsite. The construction work was estimated to take 1.5 months.

There are two other water tanks built by the Arid Lands Resource Management Project on the site.-Discussions between the County water engineer and workers revealed the need for very close supervision in the construction of the water tank.

Photo 8: Construction materials at the water tank site

Photo 9: Workers setting up at the water tank site

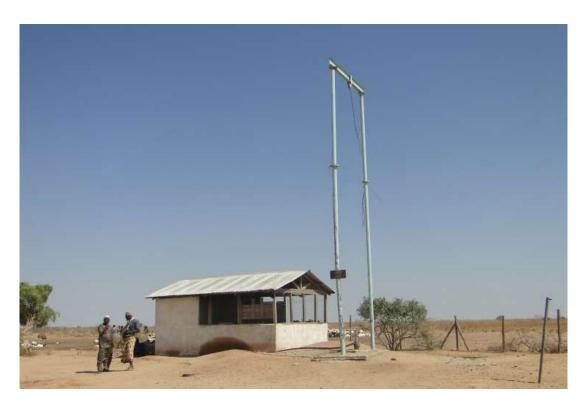
Photo 11: Uura borehole

The team visited Uura, Yamicha and Duma boreholes. Uura and Yamicha boreholes were open and in use. The CAPC team was informed that communities around these two boreholes organised themselves and mobilized resources to open and operate them. This could point to the need to strengthen the RUA for better oversight and management of these water resources.

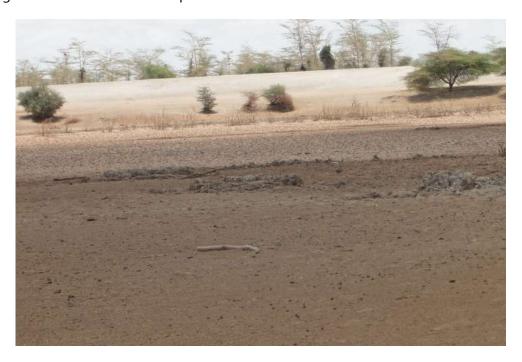
Photo 15: Yamicha water pan

The team visited Yamicha water pan which covers a very large area. It did not contain water at the time of the visit. However, the CAPC team was informed that when there are good rains, it fills up and overflows at times. The survey findings and proposals were shared. Beacons marking the proposed blockage of the inlet to the water pan were sighted. It was TAMD Monitoring Visit Report

Results of the survey by the water engineer recommended blockage of the water pan's inlet as opposed to backfilling the entire water pan. This would achieve the desired result at reduced costs, and still allow the option of opening and using the water pan again in future should the need arise. This recommendation was agreed to by the community. The need for an environmental impacts assessment on the area surrounding the water pan, and integration of environmental mitigation measures into the project was underscored due to soil erosion of its spillway.

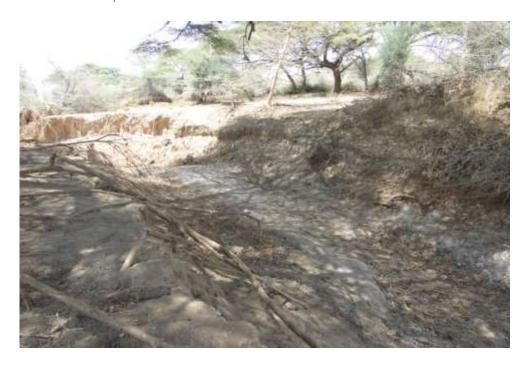
Photo 16: Spillway of Yamicha water pan

observed that the spillway was quite eroded. Its state could be worsened by the proposed blockage of the inlet to the water pan.

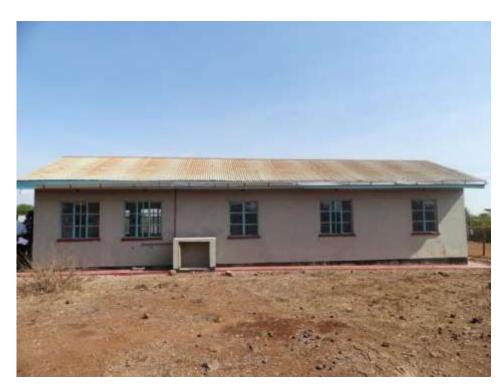
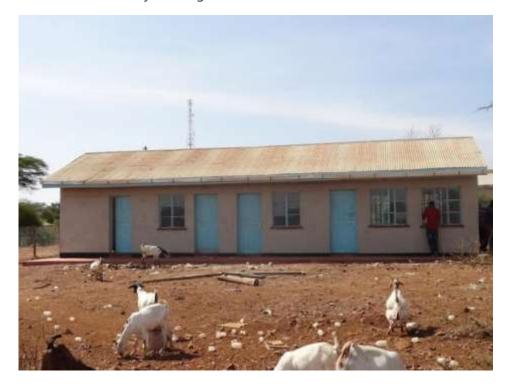
The rehabilitation of the laboratory was 90% complete. The renovations on the outside and inside of the building had been completed. The pit latrines had been built on the compound away from the main building. An incinerator for laboratory waste disposal had also been built in the compound. The major work that needed to be completed was the application for installation of electricity to Kenya Power. The contractor Mr Galgalo Halake had pre-financed the project and the WAPC were happy with the progress of the renovations.

Photo 17: Back of the laboratory building

Photo 18: Front of the laboratory building

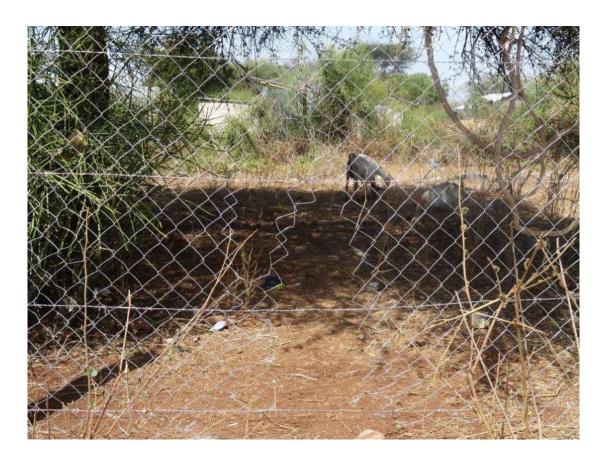
Photo 23: Hole in laboratory fence

The compound that housed the laboratory was fenced with eucalyptus poles and a wire fence. The fencing was adequate; however the fence included the agricultural office that is in the same compound as the laboratory. Dr Kithinji (Isiolo County Veterinary Director) advised that the fence should be built strictly around the veterinary laboratory only as there could be a risk of contamination if community members walk in to the laboratory compound to the agriculture office. The suggestion was put forward to the contractor and he agreed to rebuild the fence with consultations with the WAPC.

An observation was made that the eucalyptus poles needed to be treated with anti-termite coating to increase their durability. The contractor agreed to treat the poles.

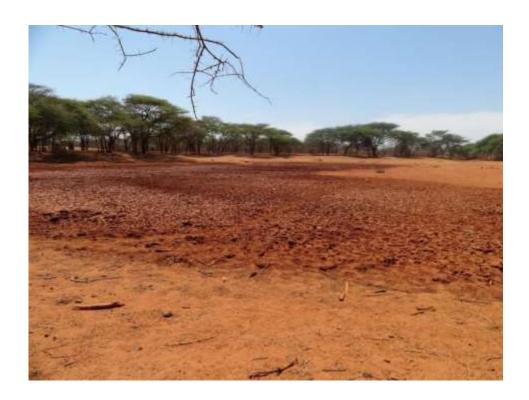
Photo 27: Harr Buyo water pan

The fencing of Harr Buyo and construction of water troughs is another of the projects that is being implemented by the Garbatulla ward adaptation committee. During the visit the monitoring team met with the contractor who had begun work 2 weeks prior to the monitoring visit. The contractor indicated that he was pre-financing the project and was currently making the concrete poles for fencing in Garbatulla town centre. At the time of the visit, he had made 30 poles and was making 10 poles per day with an aim to make 250 poles to complete fencing. The contractor expressed that one of the constraints during the construction work was availability of water. He was fully committed to completing the project and building the water troughs and the pump house for the diesel fuelled generator. At the time of the visit, the pan was empty. It had been envisioned that the fencing would be done before the short rains commencing mid-October however this did not happen.

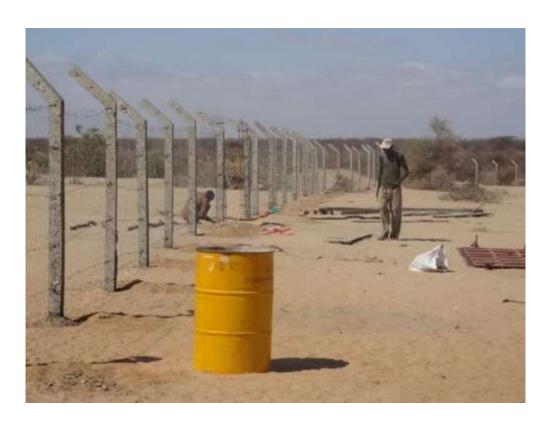
Photo 30: Fencing at Manyangap pan

first week of November. The team met the contractor from Nagayo general contractors at the site. The contractor was using concrete poles and wire fencing around the pan. He indicated that lack of water was a huge constraint during the construction and had been buying water at Kshs 40 for 30 litres from Modogashe town centre.
TAMD Monitoring Visit Report

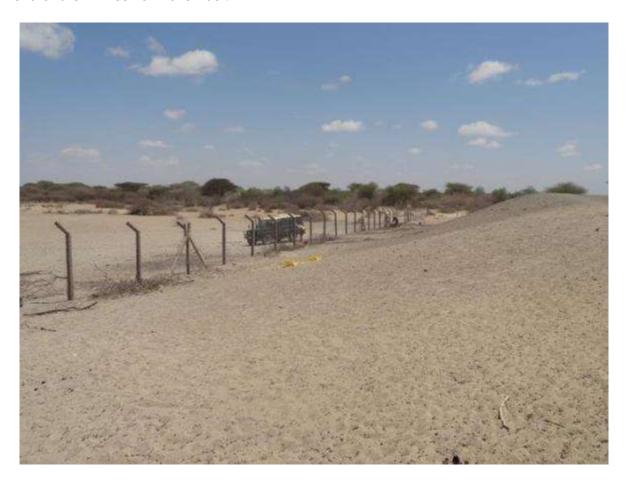
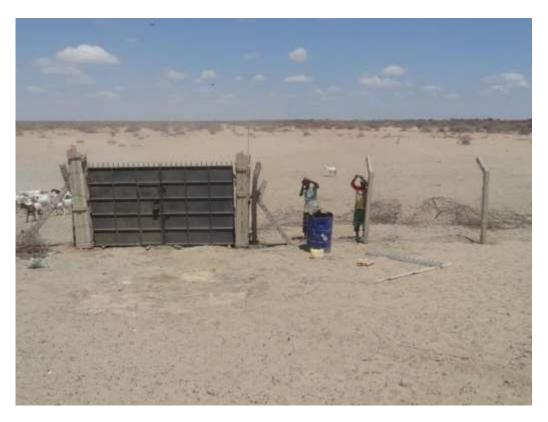
The monitoring visit team visited the Fororsa water pan and met the contractor, the local chief and the water source manager (aba-erega). From observation, the fencing of Fororsa water pan was almost complete and the contractor was hoping to complete the work by the end of the $\mathbf{1}^{\text{st}}$ week of November.

Photo 32: Fencing at Fororsa pan

Photo 33: Gate and fence at Fororsa water pan
