# **A hydrological assessment and watershed management plan for the Talvan water catchment**

**Christopher Cox  
November 2004**

**Developing markets for watershed protection services and improved livelihoods**

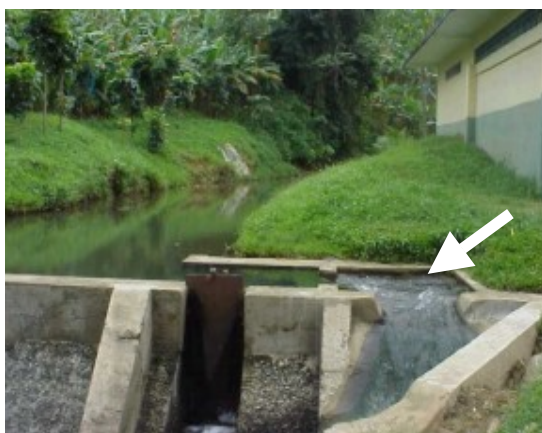
**Figure 2: Talvan intake (abstraction location indicated by arrow; pump house at right; note bananas on riverbank)**

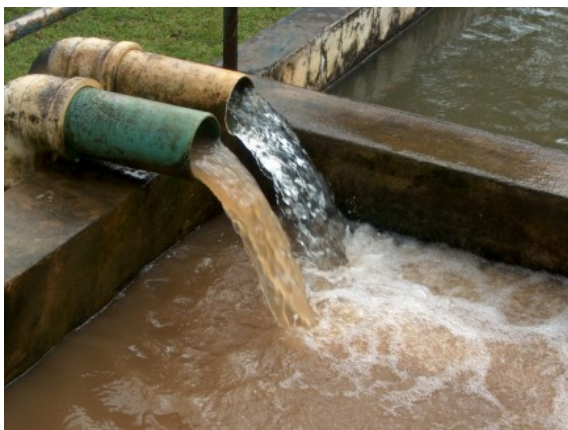
**Figure 4: Raw water to Hill 20 Treatment Plant following heavy rain. (The highly turbid Talvan catchment supply is to the left and the adjacent Marquis catchment supply is on the right.)**

The influence of land use and other practices on the water quality at the intake has been clearly manifested. A study carried out by the Caribbean Environmental Health Institute (CEHI) between December 2003 and May 2004 revealed that the raw water quality from Talvan was generally poor. Talvan had consistently elevated turbidity, nitrate, and fecal coliform levels as compared to the other tested sources. During heavy rains the intake must be closed due to heavy sedimentation (Figure 4), although recent modifications to the intake structure have permitted abstraction to minimise sediment uptake.

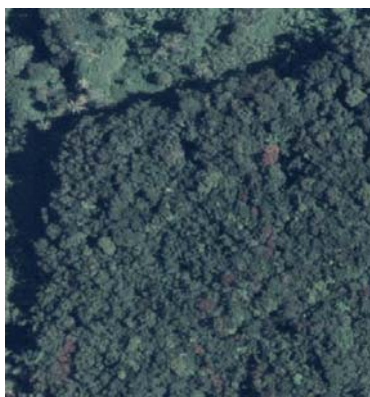
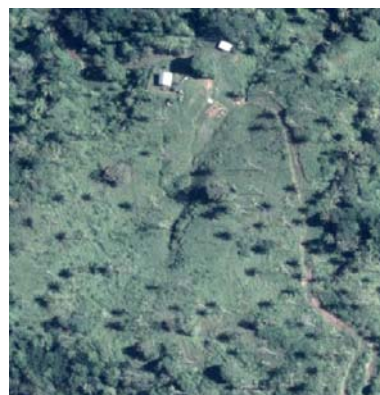
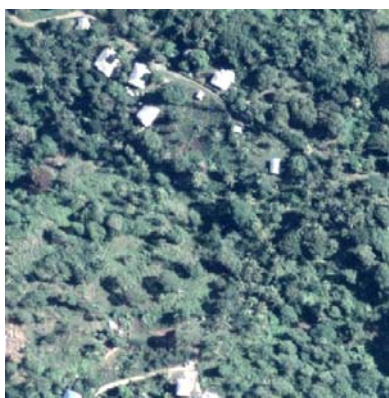
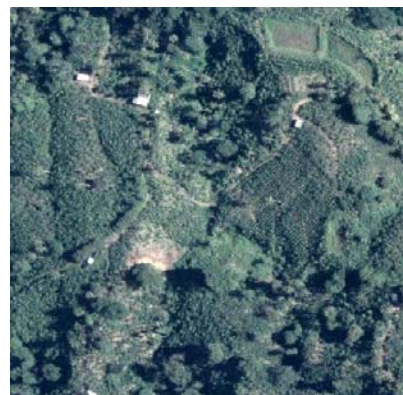
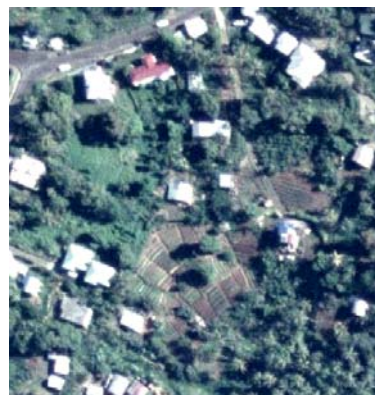
CLASS A: Primary (including plantation) forest. Photo shows sharp divide between cultivated areas and the Castries Waterworks Forest Reserve at Forestiere.

CLASS B: Abandoned cultivation / fallow lands. Dominated by regenerating vegetation and scattered tree crops; mango, breadfruit, coconut.

CLASS C: Mixed farming; temporary crops (bananas, vegetables) with tree crop overstorey (mango, breadfruit, coconut) along with fragments of secondary forest.

CLASS D: Intensive hillside cultivation; predominantly bananas and vegetable production (fish ponds are visible in the upper right corner of the photo).

CLASS E: Densely vegetated low-intensity agriculture, dominated by tree crops (mango, breadfruit, coconut, others) and dense residual (secondary) forest cover.

CLASS F: Intensive vegetable cultivation; backyard gardens.

CLASS G: Rural settlement.

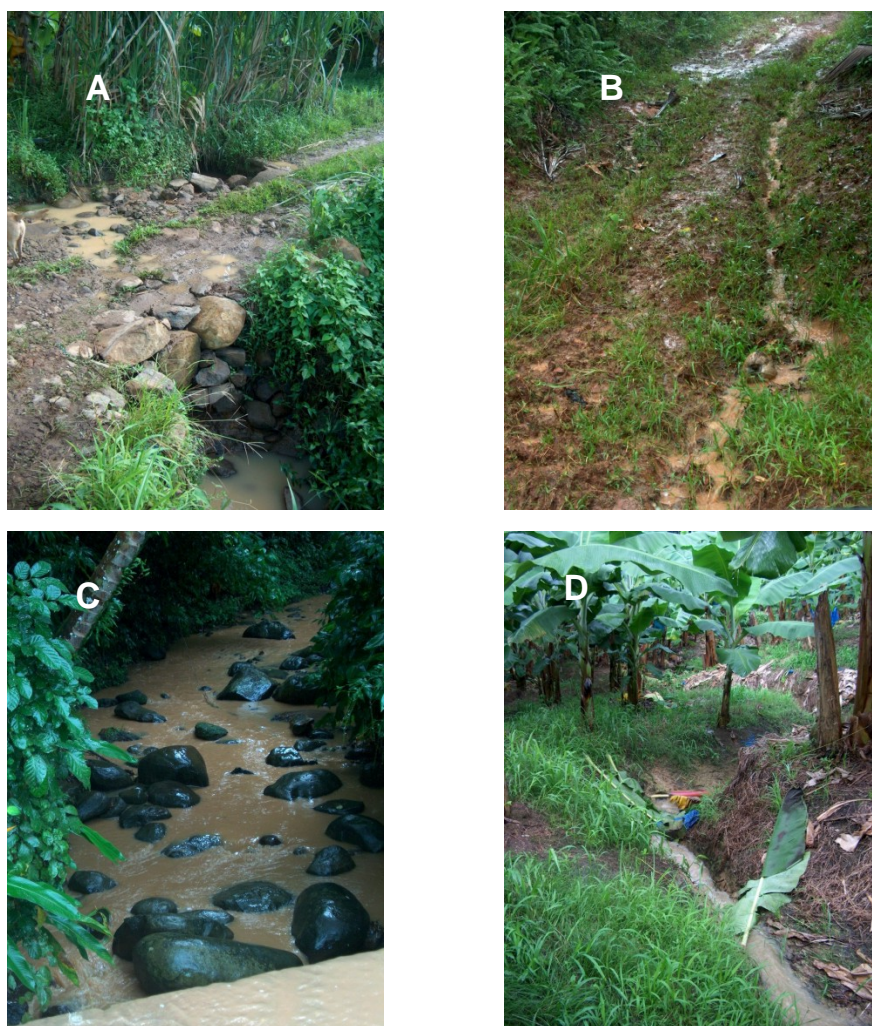
- A: Damaged road culvert along Combat Road (R1 – Figure 14)  
 B: Overland erosive flow on road cut during heavy rain (R3 – Figure 14)  
 C: Sediment-laden flow upstream of Cacao Bridge during heavy rain (R3 – Figure 14)  
 D: Rapid erosive flow during heavy rain in farm drain

**Figure 13: Erosion sources and sediment transport in the Talvan watershed.**

A major sediment source noted by both WASCO and Forestry Department personnel was a road cut at the Cacao Bridge (Figure 13C). During the October 21<sup>st</sup> site visit, which coincided with a two-hour thunderstorm event, runoff and gullying over this road surface was observed. The road remains in an un-motorable state. Another likely source is the area in the vicinity of a vehicle yard and cut hill slope at Guesneau, which fall within the headwaters of a major tributary draining the western reaches of the watershed. During the October 21<sup>st</sup> assessment, the flow in that tributary was heavily sediment-laden. Other areas of concern include road crossings over tributaries in the upper Combat area and in all areas under banana cultivation.

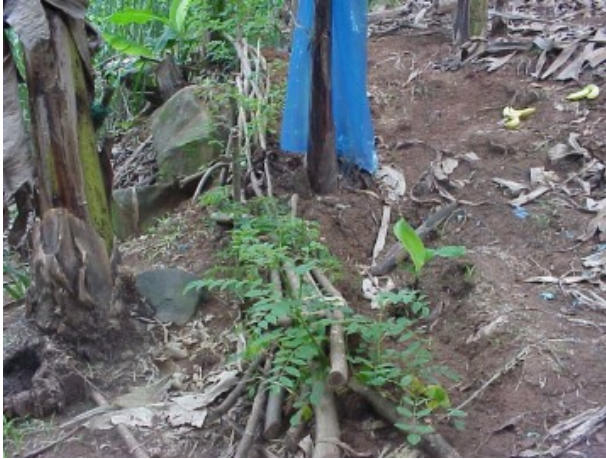
**C. Wattles (fascines):** A wattle or fascine is a bundle of live woody stems which, when placed along the contour in direct contact with the ground, propagates to produce a dense hedgerow. This measure serves to arrest surface wash of eroded material upslope behind the wattle. A variety of plant material can be used; gliricidia and bamboo among the species that can be easily used for this purpose. Wattles have been installed along the main river at Talvan as a frontline defence to reduce sediment wash from adjacent cultivations.

**Gliricidia wattle installed under banana cultivation at Talvan in alignment with the river bank**

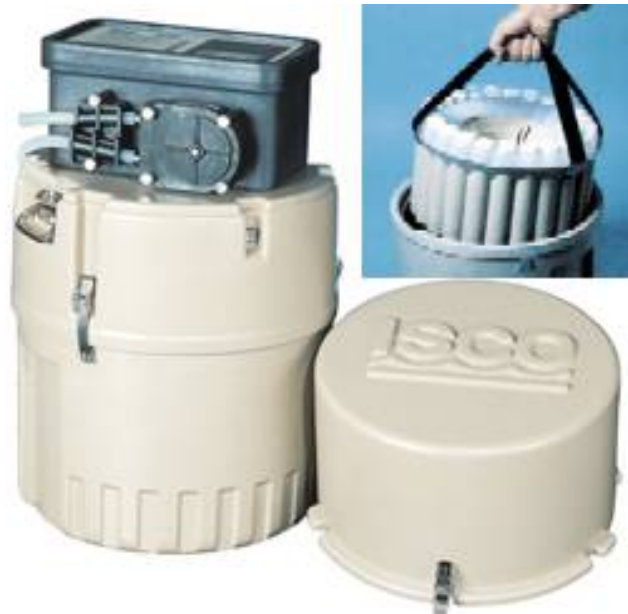
There is a variety of automatic pumping samplers that can be programmed to extract water samples from the stream flow, either on a time-based interval or on flow-paced intervals (usually to coincide with runoff events associated with rainfall). Samplers like the one illustrated (ISCO sampler at right) are outfitted with a removable bottle chamber that rotates to obtain sequential samples. The sampler is usually installed, along with the flow meter instrumentation, in the equipment shed adjacent to the weir or flume.
